Top Tether Hook Replacement

WARNING: THE TETHER HAS BEEN DESIGNED TO INDICATE WHEN THE CHILD RESTRAINT HAS BEEN IN A SEVERE CRASH AND REPLACEMENT OF THE CHILD RESTRAINT IS NECESSARY.

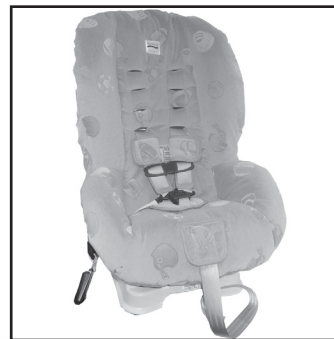
Figure 1 shows Items needed for top tether hook replacement.

Included in Kit:

- "DO NOT USE" label
- Replacement top tether hook

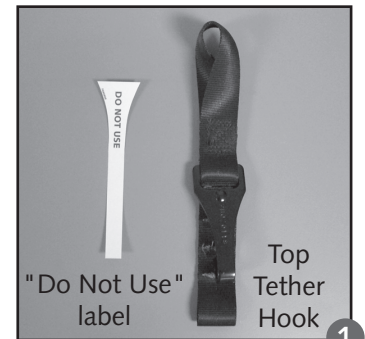
1. Place child restraint on a flat surface facing away from you, Fig. 2.
2. Locate the top tether hook on the rear of the restraint, Fig. 3.
3. Place the "DO NOT USE" label included with this kit over the top tether hook (lot number KGR01A) attached to your restraint.
 - a. Start by attaching the thin end of the label to the hook tongue underneath the rivet on the back of the top tether hook, Fig. 4.
 - b. Continue to wrap the label along the length of the hook, pressing firmly to ensure the adhesive covers the connection point between the tongue and hook, Fig. 5.
 - c. The label should terminate beneath the rivet on the front of the top tether hook, Fig. 6.

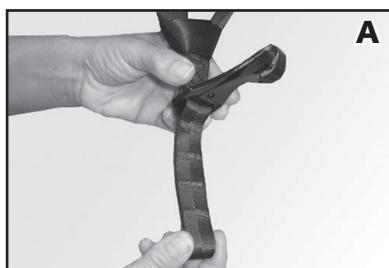
Figure A shows the tether when the child restraint is acceptable for continued use. The hook will be held in place at the top of the loop by all four rows of stitching.

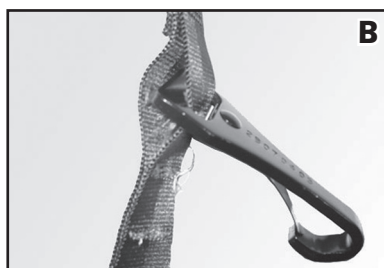
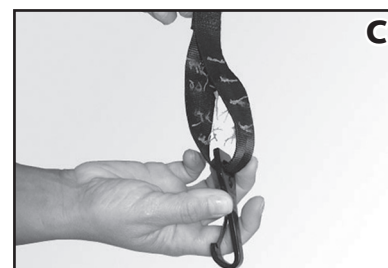
Figures B and C show the tether when the child restraint is unacceptable for continued use. All four rows of stitching are required to provide maximum protection in the event of impact. If the hook rips through any stitching on the tether lanyard, discontinue use of the child restraint and contact Britax Consumer Services for further instruction.

IMPORTANT: Regardless of whether the colored stitching has been ripped or not, discontinue use of restraint if it has been involved in a moderate to severe crash.
